# Telluride Valley Floor

## Environmental Report

May 2009

Prepared by:  
Ecological Resource Consultants, Inc.  
ERO Resources Corporation

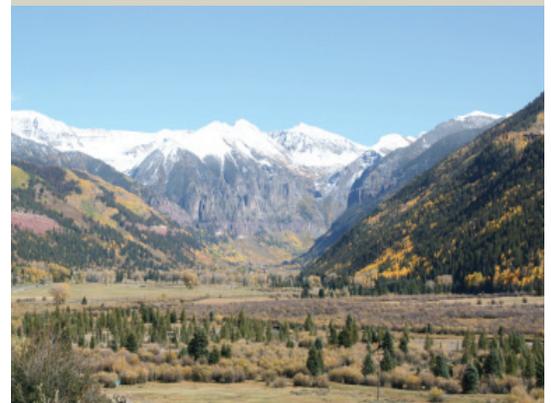
Photo 3

The Study Area (**Photo 3**) encompasses approximately 560 acres extending 2.75 miles east from Society Turn to Town. The Study Area is bordered to the east by an undeveloped Town-owned property (the Pearl Property), to the south by USFS land, to the west by State Highway 145/Society Turn, and to the north by the former State Highway 145 Spur, which was purchased by the Town 1994 and is currently known as the "Spur" (**Figure 1-2**). The Spur turns into Colorado Avenue in Town. The 560-acre Study Area is a portion of the Town property legally described in **Appendix A**.

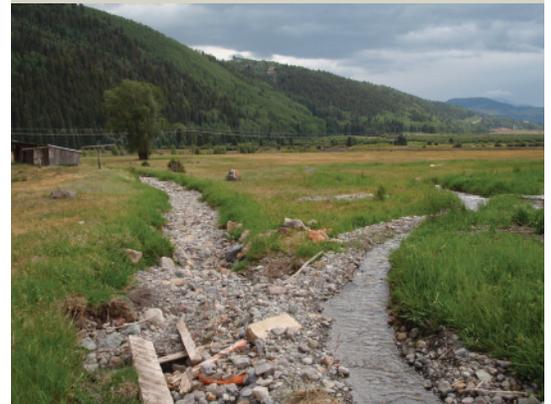
Photo 8

Numerous ditches line the upland agricultural fields diverting water from natural tributaries altering and re-directing flow affecting local vegetation, wildlife, and the amount of water flowing to the San Miguel River (**Photo 8**).

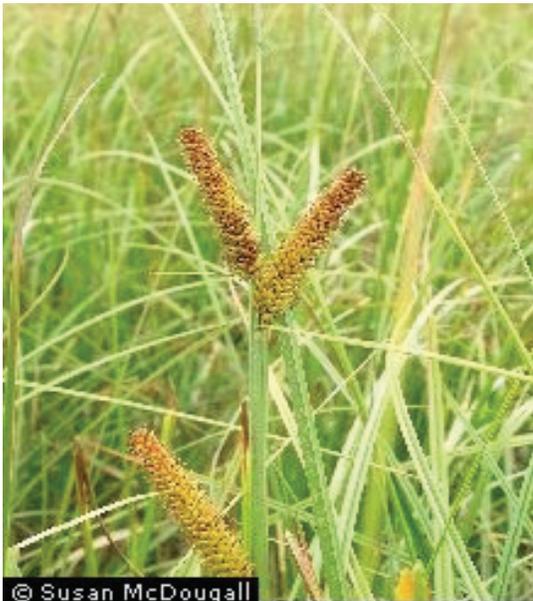
Photo 11

- Hydrophytic vegetation (**Photo 11**);
- Hydric soils (**Photo 12**); and
- Wetland hydrology (**Photo 13**).

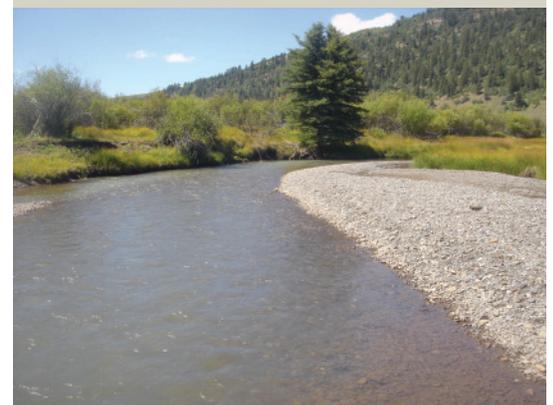
Photo 16

Waters of the US were classified into the Riverine System and consisted of two Subsystems: Riverine Lower Perennial (R2) and Riverine Upper Perennial (R3). The Riverine System includes all wetlands and deepwater habitats contained within a channel, with two exceptions: (1) wetlands dominated by trees, shrubs, persistent emergents, emergent mosses, or lichens, and (2) habitats with water containing ocean-derived salts in excess of 0.5%. The Riverine System is bounded on the landward side by upland, by the channel bank (including natural and manmade levees), or by vegetated wetlands (**Photo 16**).

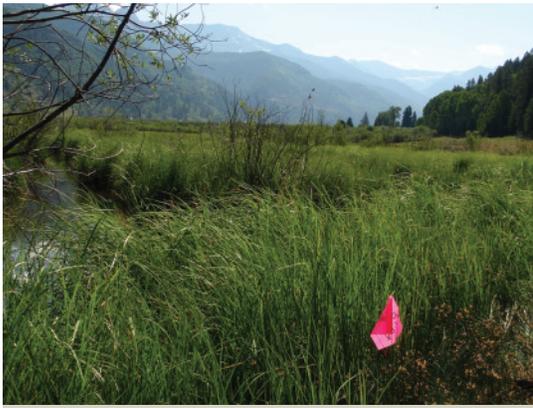
Photo 17

PEM wetlands are characterized by erect, rooted, herbaceous hydrophytes including mosses and lichens. This type of vegetation is present for the majority of the growing season in most years. PEM wetlands are often dominated by perennial plants (**Photo 17**).

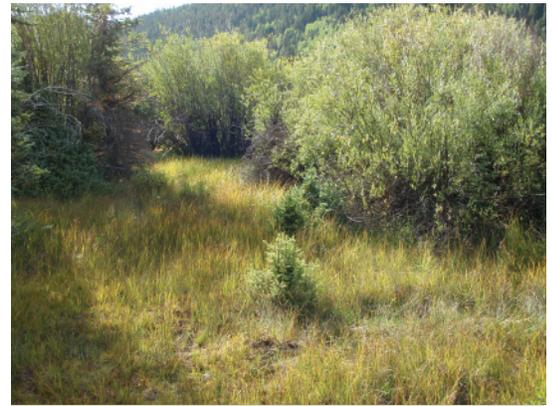
Photo 18

PSS wetlands are dominated by woody vegetation less than 20 feet tall. Typical species include shrubs, young trees and trees or shrubs that are small or stunted because of environmental conditions (**Photo 18**).

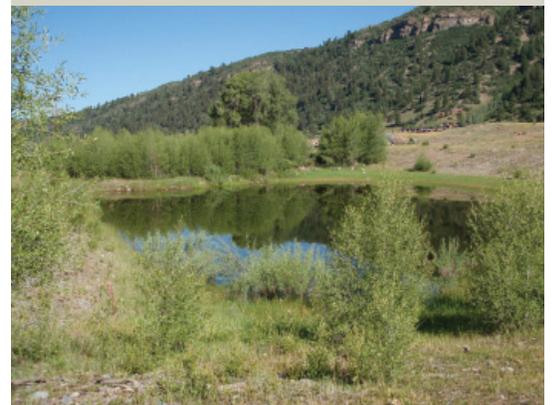
Photo 20

POW wetlands are typically dominated by open water and are permanently flooded. They include unvegetated areas less than 20 acres in size with water depths in the deepest part under 6.6 feet at low water (**Photo 20**).

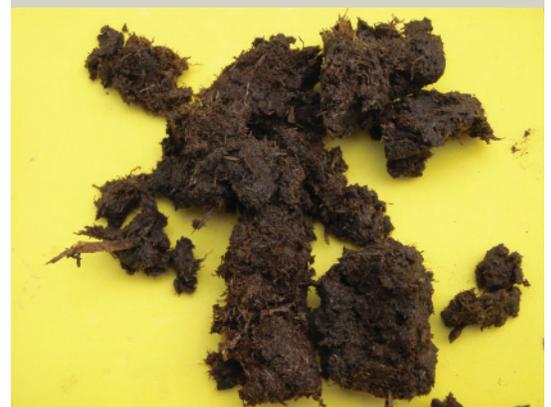
Photo 25

Histosols are defined as organic soils that contain 16 inches or more of organic soil material within the upper 32 inches of a soil profile (USDA-NRCS 2006). Organic soil material must have an organic carbon content (by weight) of 12-18% or more, depending on the clay content of the soil (**Photo 25**). One PSS willow-sedge wetland complex located adjacent to Butcher Creek in the eastern section of the Study Area contains histosol soils. This PSS wetland complex is dominated by Geyer willow midstory with a thick water sedge understory. The vegetation root matting is substantial with deep sedge tussocks interspersed beneath the willow. The water regime is semi-permanently flooded with the water table present approximately one inch below the ground surface. The soil material in this wetland complex is classified as peat (i.e., undecomposed plant material) due to the fibric organic content of the soil. The organic content was visually assessed with no lab analysis. Soil cores were dug throughout this wetland complex to define the boundaries. The limits of the histosol are generally within the PSS wetland complex, and extend slightly into the adjacent PEM wetland complex (see WA19 in the *Summary of Assessment Area Characteristics* section).

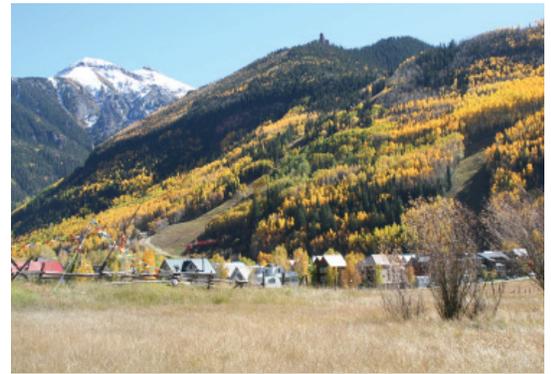
Photo 26

- Forest – Trees with their crowns overlapping (generally forming 60-100% cover) (**Photo 26**).
- Woodland – Open stands of trees with crowns not usually touching (generally forming 25-60% cover). Canopy tree cover may be less than 25% in cases where it exceeds shrub, dwarf-shrub, herbaceous, and nonvascular cover, respectively (**Photo 27**).
- Shrubland – Shrubs generally greater than 1.6 feet tall with individuals or clumps overlapping to not touching (generally forming more than 25% cover, trees generally less than 25% cover). Shrub cover may be less than 25% where it exceeds tree, dwarf-shrub, herbaceous, and nonvascular cover, respectively. Vegetation dominated by woody vines is generally

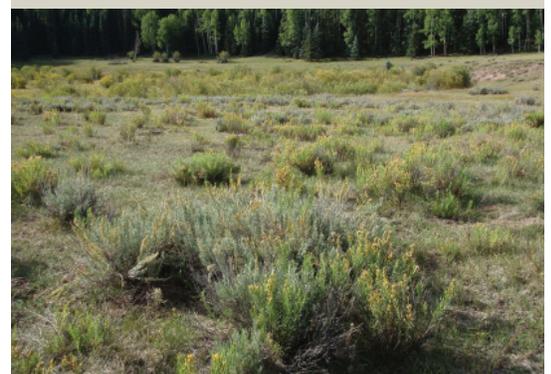
Photo 29

- Dwarf-Shrubland – Low-growing shrubs usually under 1.6 feet tall. Individuals or clumps overlapping to not touching (generally forming more than 25% cover, trees and tall shrubs generally less than 25% cover). Dwarf-shrub cover may be less than 25% where it exceeds tree, shrub, herbaceous, and nonvascular cover, respectively (**Photo 29**).

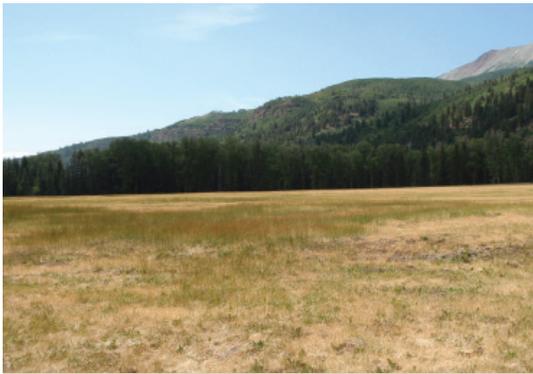
Photo 30

- Herbaceous – Herbaceous vegetation (graminoids, forbs, and ferns) dominant (generally forming at least 25% cover; trees, shrubs, and dwarf-shrubs generally with less than 25% cover). Herbaceous cover may be less than 25% where it exceeds tree, shrub, dwarf-shrub, and nonvascular cover, respectively (**Photo 30**).

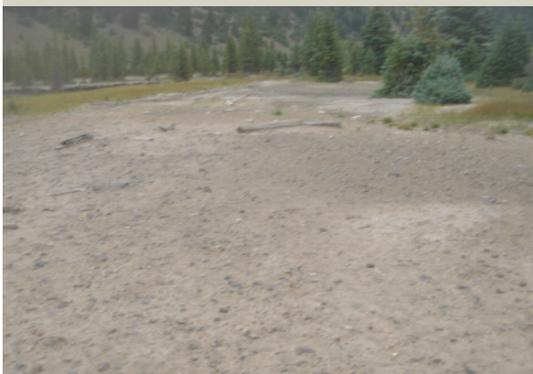
Photo 32

- Sparse Vegetation – Abiotic substrate features dominant. Vegetation is scattered to nearly absent and generally restricted to areas of concentrated resources (total vegetation cover is typically less than 25% and greater than 0%). Sparse Vegetation types are primarily based on substrate features, rather than vegetation (**Photo 32**).

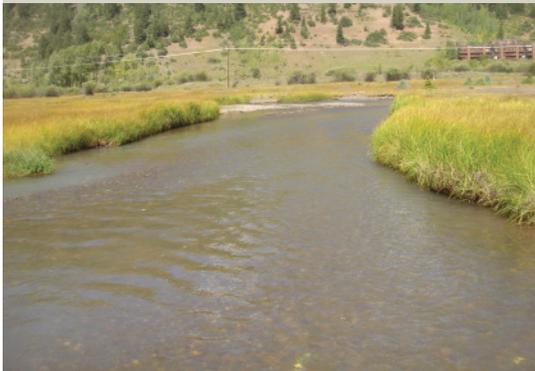
Photo 40

Sample 1 is located along the eastern section of the San Miguel River near the USFS boundary (**Photo 40**). This section of the channel is linear, with no discernable meanders or bends. This section is heavily channelized by the historic railroad grade to the north. Water depths were approximately one foot deep. The bottom is primarily cobble substrate. The banks of this reach are vegetated with conifers and willows.

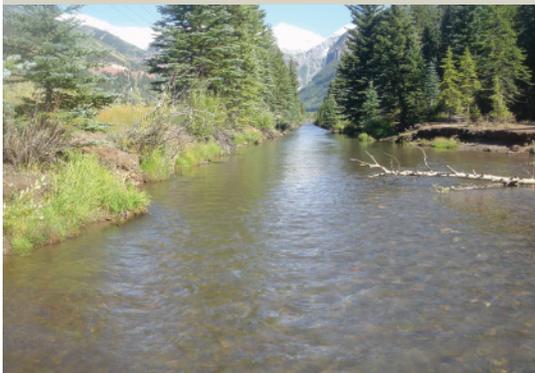
Photo 41

Sample 2 is located along the southern channel after the San Miguel River splits (**Photo 41**). Located along a bend, this location is characterized by a mixture of 1-2 foot deep riffles and three pools ranging in depth from 3-5 feet. The bottom is primarily cobble substrate, with accumulated sediment within the pools. The banks of this reach are vegetated with conifers and assorted grasses.

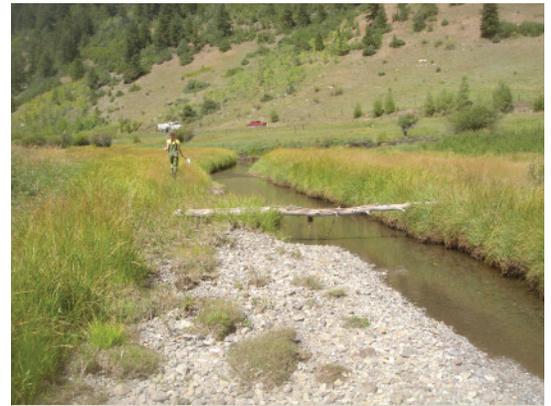
Photo 42

Sample 3 is located along the northern channel after the San Miguel River splits (**Photo 42**). Moderately channelized, the area is just upstream from a spring fed intermittent stream. Substrate is composed of cobble and silt. Water depths range from 3-6 inches in cobble areas to approximately 3 feet within the lone pool observed in this reach. The banks of this reach are eroded along the mild bends and vegetated with assorted sedges and rushes.

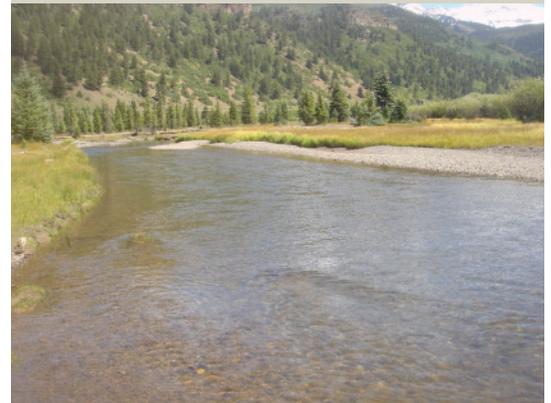
Photo 43

Sample 4 is located along the western section of the San Miguel River after the northern and southern channels merge (**Photo 43**). The sampled reach encompassed an area downstream and upstream of two bends and included

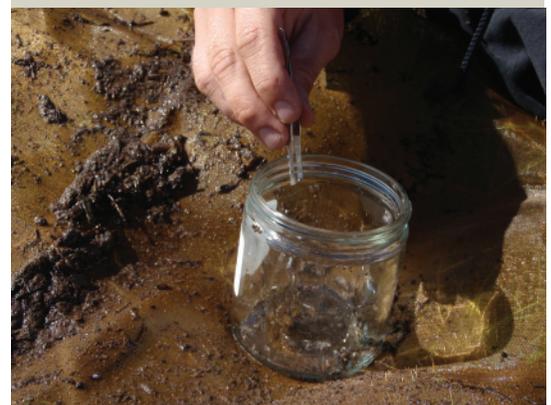
Photo 44

The identified portion of the sample was placed in a 20 milliliter glass scintillation vial with polypropylene lids in 70% ethanol, given a catalog number, and retained (**Photo 44**). In this report, metrics were calculated using data from the sub-sampled and big/rare portions of the sample. Abundance data are presented as the estimated number of individuals per square meter for quantitative samples and the estimated number per sample for qualitative samples.

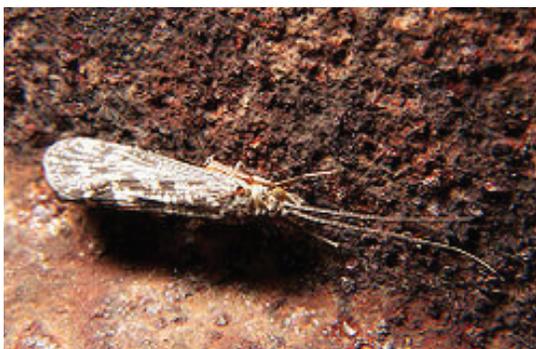
Photo 89

The Study Area ecosystem supports, and is sustained by, a host of insects and invertebrate species. The 2002 SEI report documented the function and importance of invertebrates within the Study Area (2002). The San Miguel River is a breeding ground for insects such as mayflies (**Photo 89**), caddisflies, and aquatic true bugs, while the wetland areas provide habitat for dragonflies, beetles, mosquitoes, and flies. Terrestrial invertebrates include beetles, butterflies, moths, weevils, true bugs, grasshoppers, and crickets (SEI 2002). Results of benthic macroinvertebrate sampling are discussed in **Section 2.3.2.2**.

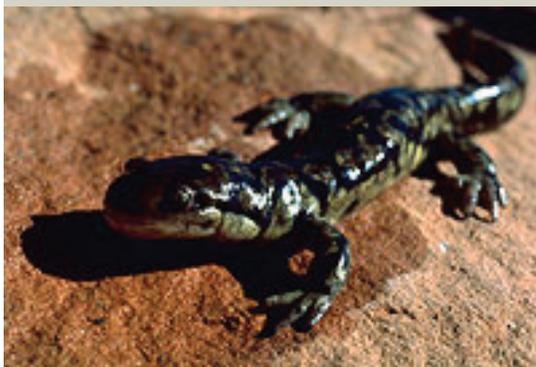
Photo 90

The extensive wetlands and ponds within the Study Area provide a large amount of habitat for amphibians, including chorus frog, northern leopard frog, bullfrog, and tiger salamander (**Photo 90**). However, considering the extensive habitat that exists, amphibians were noticeably absent from the Study Area during the site visits. While some community members have reported hearing chorus frogs or possibly bullfrogs in June, no amphibians of any kind were observed during the wetland and wildlife studies conducted in July.

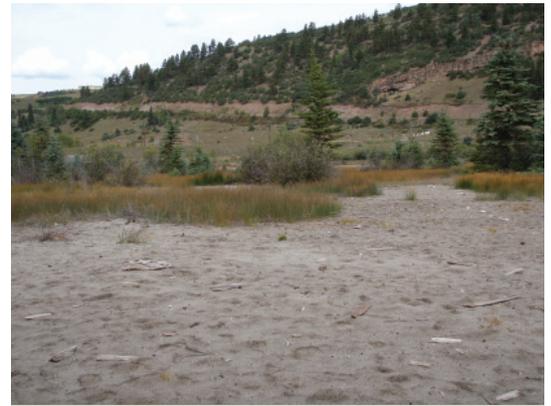
Photo 91

Most of the tailings piles within the Study Area originated from the Idarado Mine facility on the east side of Town (**Photos 91 and 92**). According to Camille Price with the CDPHE, most of the tailings were transported as sediment in the San Miguel River, and were then deposited alluvially behind an impoundment located near Society Turn. A placer mining operation at Keystone, located immediately west of Society Turn and the Study Area, was reportedly mining the alluvial deposits in the valley for gold in the late 1800s.

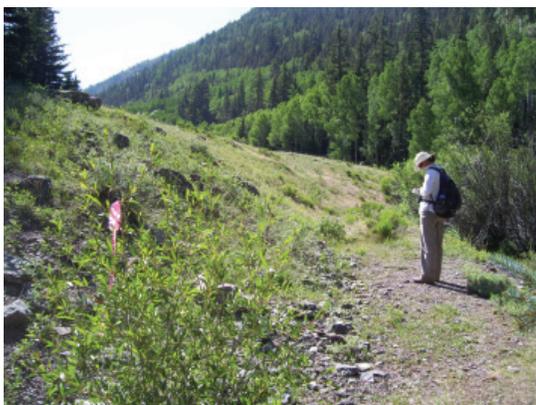
Photo 98

A Class I cultural resources reconnaissance survey (consisting of a review and synthesis of all existing literature and records, and a “walkover” survey of the Study Area) was conducted July 29-31, 2008 within the Study Area (**Photo 98**). The survey was conducted by walking unsystematic transects across the Study Area in areas of likely cultural resources. These areas included tracts of land not currently inundated with water or areas of perennial wetlands. Discovered cultural resources were located using GPS, photographed, and incorporated into project base mapping. Observed cultural resources, their significance, and overall sensitivity rating are listed on **Table 2-12**. Specific locations of cultural resources described in the following section can be found in **Figures 2-15 and 2-16**.

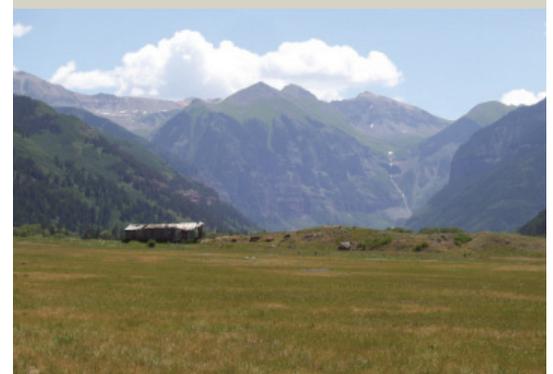
Photo 103

The Vezina ranch was acquired in the 1950s located near the present-day sewer lagoons and included a two-story house and barn with corrals (Mahoney pers. comm. 2008) (**Photo 103**). Tilman Beam leased the ranch from Silvio Oberto beginning in the early 1950s and ranched the property throughout the 1950s and early 1960s. Beam built the corrals that still stand east of the Shell gas station. Don Oberto relates that the three or four remaining structures from old San Miguel City were burned by him and Beam, probably in the late 1950s (Oberto n.d.). The Telluride USGS 7.5 minute topographic quadrangle dated 1955 shows five structures on the south side of the Spur. Presumably these structures were burned by Beam shortly after the USGS quadrangle was produced. Don Oberto also relates that the old school house foundation was located in the grove of cottonwood trees to the west and south of San Miguel City (no evidence was found of this structure). Beam was also responsible for a network of irrigation ditches that diverted water from either side of Mill and Eider Creeks. Holstein cows were introduced to the valley in the 1950s as well, but the altitude culled about 10% of the herd in the first year and the remaining cows were sold within a few short years. This appears to have been the last significant dairy effort in the valley, despite an oral interview with Carlie McKnight who asserted that that the Hughes ran the last dairy operation (Neely and Archimedes 2004).

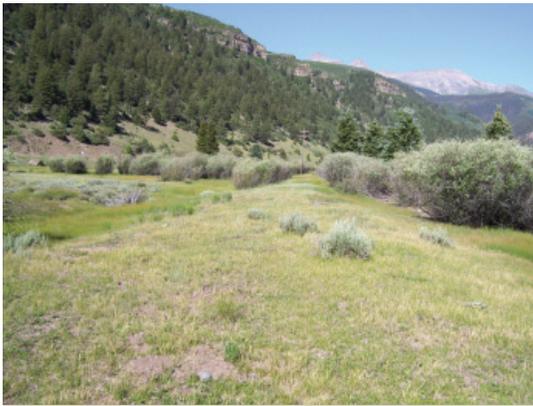
Photo 104

It was noted in the Nickens report that the railroad grade had been previously recorded as 5SM.1024 and was recommended not eligible for listing on the National Register of Historic Places (NRHP) (Photo 104). A 2007 notation in the report by OAHP staff noted that the designation 5SM.1024 had been changed to 5SM.2030.19 and that the documented boundaries of the Telluride Spur through the valley remain unknown. Additional research suggests that the railroad grade within the valley located within the Study Area has not been formally documented except for that portion that falls on USFS property. This segment, 5SM.2030.19, was documented during the Telluride Ski Area Expansion project (SM.FS.R71) in 1983 (Eininger and Gaunt 1984). The segment was determined officially not eligible due to a loss of physical integrity – all railroad ties have been removed and a modern sewer line has been placed within portions of the grade.

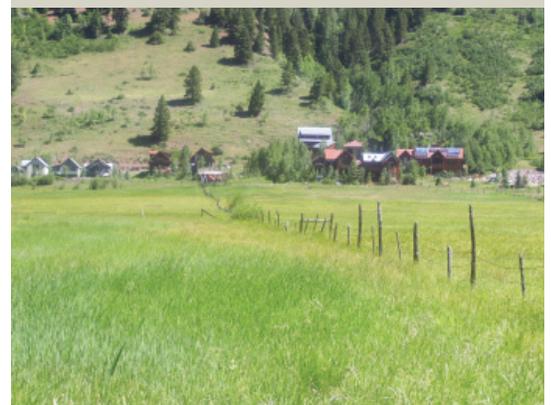
Photo 109

San Miguel City is considered a significant historic resource at all three levels (**Photo 109**). Although no physical remains exist south of Highway 145, the area is defined by its plat and through historic photographs. San Miguel City would contribute to the Victorian and early mining settlement theme defined in Colorado (Church *et al.* 2007) and undoubtedly retains buried cultural deposits in the form of cellars and outhouses. It therefore has the potential to contribute significant additional information through excavation. Ground disturbing activities should be avoided in this area. Geophysical investigations have the potential to define the limits of San Miguel City.

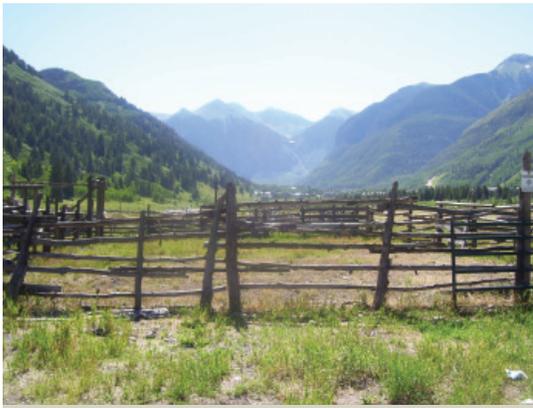
Photo 110

The corral and ranch gates are considered significant at the local level for their association with historical ranching in the valley and their association with a locally significant person (**Photos 110 and 111**). Preservation initiatives could include evaluating the corral for stabilization measures, if necessary. The "llama shed" located on the Pearl property in the northeast corner of the study area was added to the historic district in 1994; it was recommended not eligible (Barbour 1994). However, both structures are recommended significant at the local level for their association with historic persons and for maintaining the historic setting of the valley.

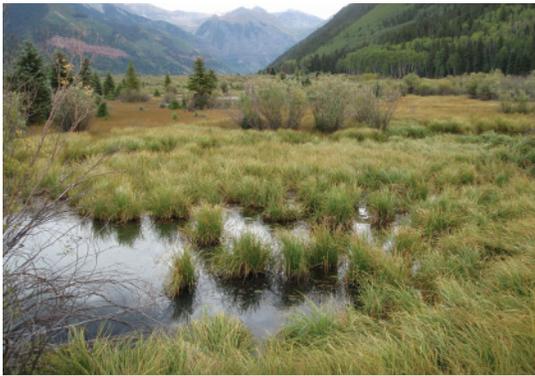
Photo 112

WA1 is a permanently flooded PEM/PSS wetland complex associated with a large beaver dam on Prospect Creek (**Photo 112**). Because of the permanently flooded water regime and low level of disturbance, 7 of 12 functions evaluated received “High” scores for this WA including a score of .9H for General Wildlife Habitat. Thus, WA1 meets the criteria for Category II ranking.

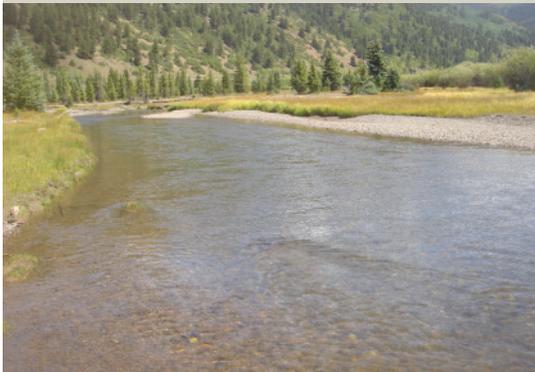
Photo 114

WA3 consists of the San Miguel River channel (R2 wetland habitat), permanently flooded PEM and PSS floodplain wetlands, and PUS/PUB gravel bars within the river channel (**Photo 114**). This complex has moderate structural diversity and moderate disturbance therefore the WA received “Low” to “Moderate” scores for 9 of 12 functions evaluated resulting in a percentage of possible points >35% and <65%. Thus WA3 meets the criteria for Category III ranking.

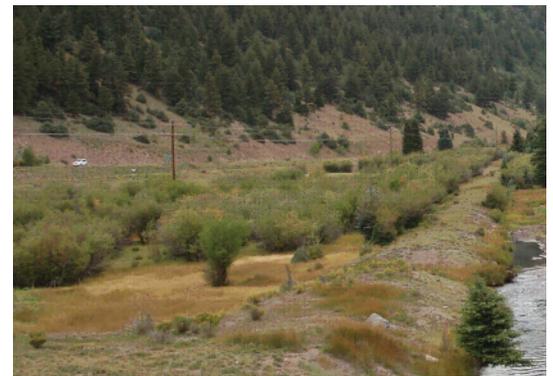
Photo 116

WA5 consists of temporarily flooded PSS wetland habitat (with small portions consisting of seasonally flooded PEM habitat) (**Photo 116**). A railroad grade separates this wetland complex almost entirely from the San Miguel River altering its natural flooding regime. Due to the high level of disturbance, this wetland complex received “Low” to “Moderate” scores for 7 of 9 functions evaluated, resulting in a percentage of possible points >35% and <65%. Thus, WA5 meets the criteria for Category III ranking.

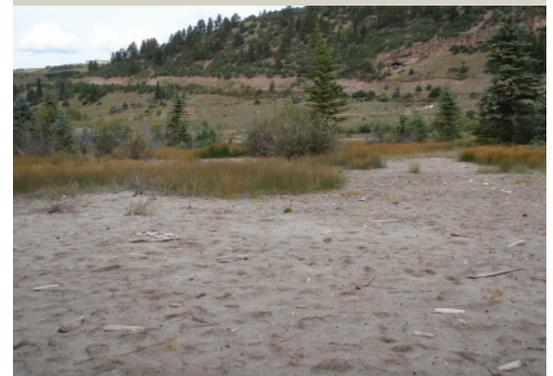
Photo 117

WA6 consists of a large seasonally flooded PFO mine tailings area (**Photo 117**). Because the wetland complex is sparsely vegetated, only seasonally flooded, and highly disturbed, 7 of 11 functions evaluated received “Low” scores for this wetland complex resulting in a percentage of possible points <35%. Thus, WA6 meets the criteria for Category IV ranking.

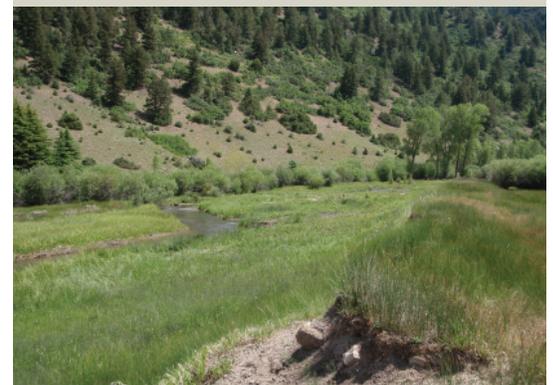
Photo 119

WA8 consists of the north fork of the San Miguel River (R2 wetland habitat) and abutting PSS/PEM seasonally flooded wetlands (**Photo 119**). The river is confined by high berms on either side, which limits the abutting wetlands. Due to this high level of disturbance, this WA received “Low” to “Moderate” scores for 7 of 12 functions evaluated resulting in a percentage of possible points >35% and <65%. Thus, WA8 meets the criteria for Category III ranking.

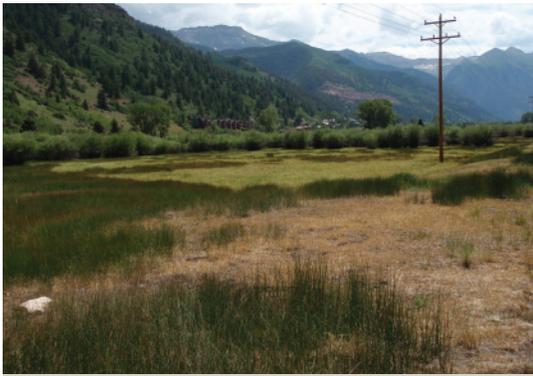
Photo 120

WA9 consists of PEM/PSS habitat that is temporarily flooded (**Photo 120**). This complex is located on an “island” between the north and south forks of the San Miguel River, confined by berms on all sides. This wetland complex received “Low” to “Moderate” scores for 7 of 8 functions evaluated resulting in a percentage of possible points >35% and <65%. Thus, WA9 meets the criteria for Category III ranking.

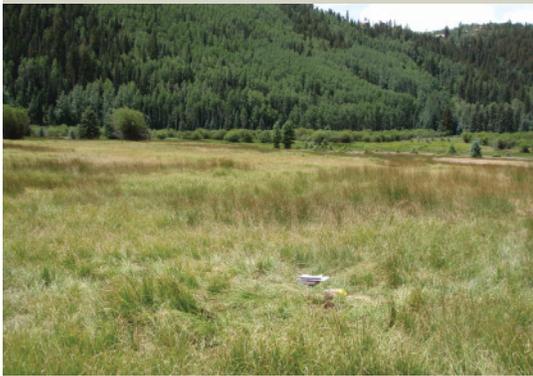
Photo 121

WA10 consists of temporarily flooded/seasonally flooded PEM habitat located on a terrace in a former oxbow, between the north and south forks of the San Miguel River (**Photo 121**). The area is located on an “island” with relatively low levels of disturbance associated with the nearby berms and the railroad grade. The WA sits atop a terrace only receiving floodwaters temporarily or seasonally during the growing season, therefore the area received “Low” to “Moderate” scores for 7 of 8 functions evaluated resulting in a percentage of possible points >35% and <65%. Thus, WA10 meets the criteria for Category III ranking.

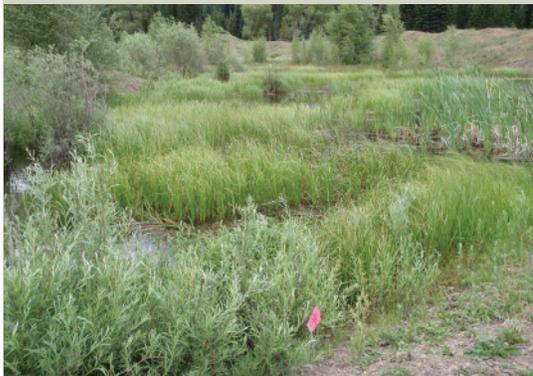
Photo 122

WA11 consists of seasonally flooded PEM/PSS habitat, and permanently flooded POW habitat located adjacent to the north fork of the San Miguel River, on an “island” (**Photo 122**). The area assessed consists of three wetland pockets, adjacent to the river, but surrounded by berms. Because of the moderate disturbance from the berms, the small size of the WA (<1 acre), and a “Low” score for Uniqueness, WA11 meets the criteria for Category IV ranking.

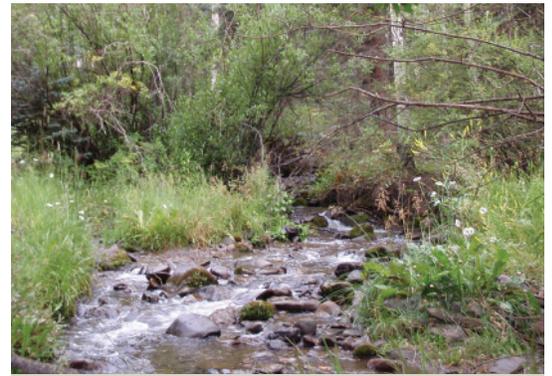
Photo 124

WA13 consists of seasonally flooded PFO habitat, seasonally flooded/permanently flooded PEM habitat, and R3 habitat associated with Prospect Creek (**Photo 124**). This forested wetland complex received “High” scores for structural diversity and “High” scores for Uniqueness (.9H) (because it is a rare habitat type within the Study Area (e.g., mature forested wetland)). Thus, WA13 meets the criteria for Category II ranking.

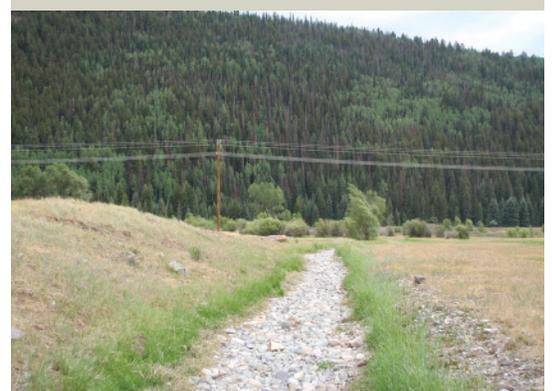
Photo 126

WA15 consists of seasonally flooded POW, PEM, and PSS habitat associated with two man-made historical sewage lagoons (**Photo 126**). Because the wetland complex received a “Low” score for Uniqueness and the vegetative component of the lagoons is <1 acre, WA15 meets the criteria for Category IV ranking.

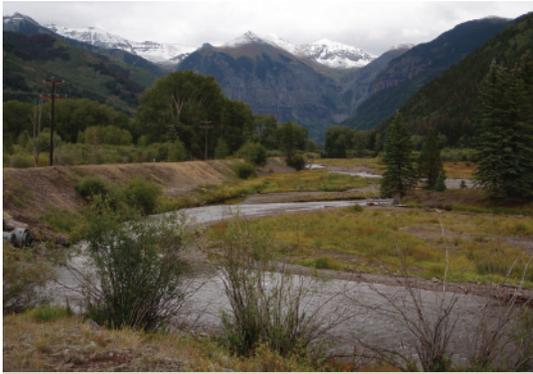
Photo 127

WA16 consists of R3 habitat associated with Eider Creek. The area is highly disturbed as a result of the lack of water in the channel (due to irrigation diversions) (**Photo 127**). The wetland complex is sparsely vegetated along the banks of the creek (the vegetated component is <1 acre), and it received “Low” scores for 10 of 12 functions evaluated, including Uniqueness. Thus, WA16 meets the criteria for Category IV ranking.

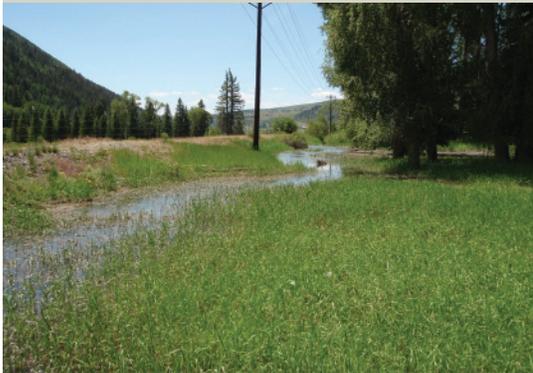
Photo 129

WA18 consists of permanently flooded/temporarily flooded PEM habitat, seasonally flooded PSS habitat, temporarily flooded PUS habitat, seasonally flooded PFO habitat, and seasonally flooded R3 habitat associated with Mill Creek (**Photo 129**). The wetland complex is highly disturbed due to the hydrologic alteration of Mill Creek from a recent flood event, in addition to seasonal water diversion for irrigation. The wetland complex received “Moderate” scores for 8 of 12 functions evaluated resulting in a percentage of possible points >35% and <65%. Thus, WA18 meets the criteria for Category III ranking.

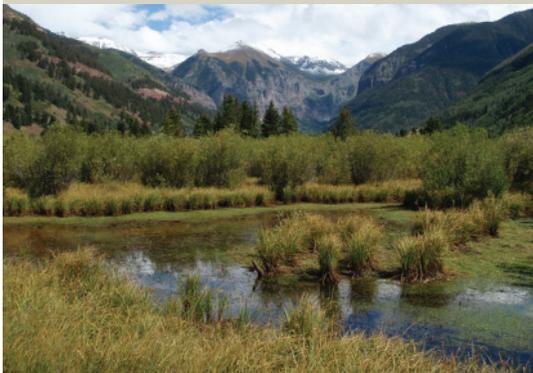
Photo 130

WA19 consists of semipermanently flooded PEM/PSS wetland habitat associated with a high groundwater table (**Photo 130**). This is a rare wetland type underlain by deep histosol soils with low disturbance, thus WA19 scored “High” (1H) for Uniqueness, which meets the criteria for Category I ranking.

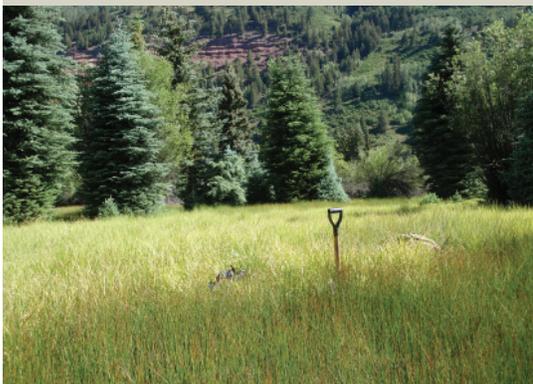
Photo 131

WA20 consists of seasonally flooded/permanently flooded PFO habitat, seasonally flooded PEM habitat, and permanently flooded PSS habitat, bordering Cornet Creek along the north side of the complex (**Photo 131**). This large wetland complex has low levels of disturbance, high structural diversity, and a permanently flooded water regime; therefore, the wetland complex received “High” scores for 7 of 9 functions evaluated, including a “High” score (.9H) for General Wildlife Habitat. Thus, WA20 meets the criteria for Category II ranking.

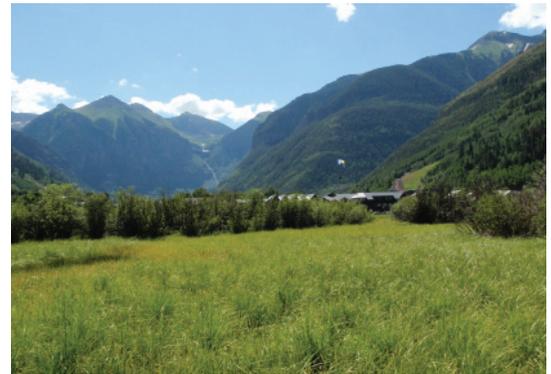
Photo 132

WA21 consists of seasonally, temporarily, and permanently flooded PEM habitat, seasonally flooded and permanently flooded PSS habitat, and POW habitat associated with numerous beaver dams on Cornet Creek/Butcher Creek (**Photo 132**). This large wetland complex has low disturbance and moderate

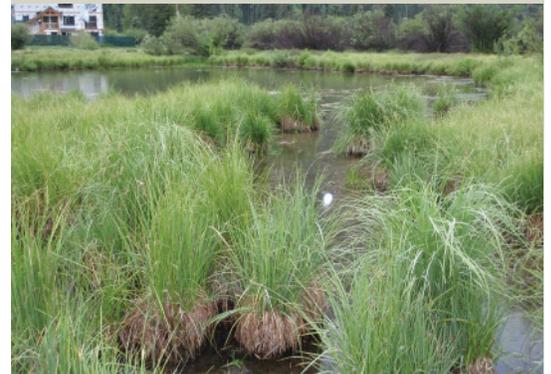
Photo 133

WA22 consists of POW habitat associated with two man-made ponds (historically excavated and intended to be used as sewage lagoons) (**Photo 133**). The complex is highly disturbed due to its artificial nature, contains low structural diversity as the vegetative component is <1 acre, and scored “Low” for Uniqueness. Thus, WA22 meets the criteria for Category IV ranking.

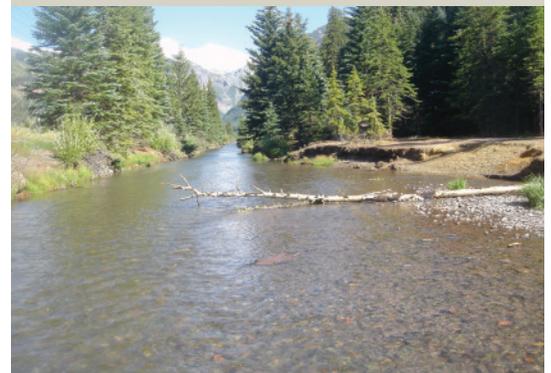
Photo 134

WA23 consists of permanently flooded R2 habitat associated with the San Miguel River and adjacent seasonally flooded PSS habitat along the south side of the channel (**Photo 134**). The complex is highly disturbed due to the extreme channelization of the San Miguel River as a result of the historic railroad grade that borders the north side. WA23 received “Low” to “Moderate” scores for 10 of 12 functions evaluated resulting in a percentage of possible points >35% and <65%. Thus, WA23 meets the criteria for Category III ranking.

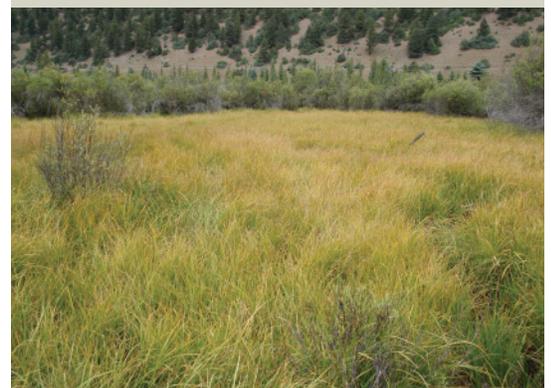
Photo 135

WA24 consists of seasonally flooded/temporarily flooded PSS habitat and permanently flooded PEM habitat (**Photo 135**). Because the wetland complex has low levels of disturbance, moderate structural diversity, and a permanently flooded water regime within a substantial portion of the complex, the WA scored “High” to “Moderate” for 9 of 11 functions evaluated, including a “High” score (.9H) for General Wildlife Habitat. Thus, WA24 meets the criteria for Category II ranking.

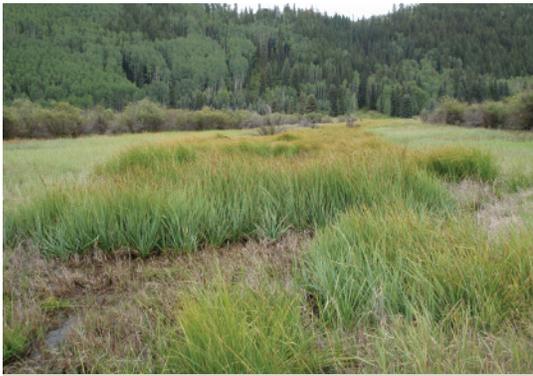
Photo 136

WA25 consists of temporarily flooded PSS habitat, and temporarily flooded, seasonally flooded, and permanently flooded PEM habitat (portions of which include a wetland mitigation area) (**Photo 136**). Because of the significant hydrologic alteration due to the induced hydrology within this wetland complex and the temporarily flooded water regime throughout most of the wetland complex, WA25 received “Low” to “Moderate” scores for 8 of 10 functions evaluated resulting in a percentage of possible points >35% and <65%. Thus, WA25 meets the criteria for Category III ranking.

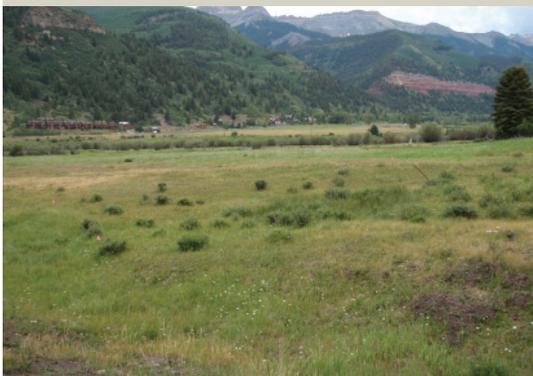
Photo 138

UA27 consists of two Willow/Mixed Grass Shrubland complexes (**Photo 138**). One large area is located adjacent to the wetland mitigation site; the second is located on the north side of the Study Area, adjacent to the bike path. These areas have moderate disturbance and moderate structural diversity, therefore 4 of 7 functions evaluated score “Low” for this UA resulting in a percentage of possible points below 35% and a “Low” score for Uniqueness. Thus, UA27 meets the criteria for Category IV ranking.

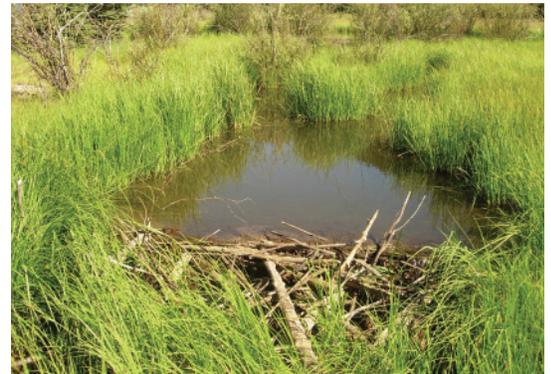
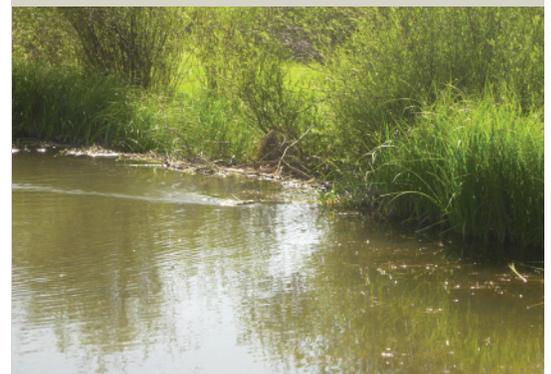
Photo 146

The Study Area is home to several families of beaver. The dam-building, canal-building, and foraging activities of beaver can have profound effects on ecosystem structure and function (Baker and Hill 2003). This is certainly the case in the Study Area where many of the wetland and open water habitats are sustained by beaver activity. Beaver dams raise the groundwater table and promote the establishment and growth of wetland and riparian vegetation, including willow and cottonwood, as well as alter vegetation species composition and aquatic habitat condition (**Photos 146 and 147**).

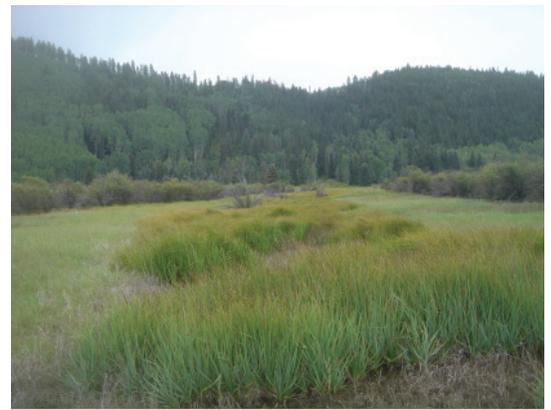
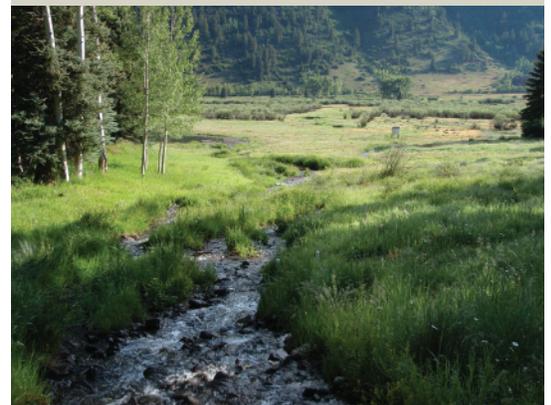
Photo 161

To facilitate the restoration of wetlands on the Prospect Creek alluvial fan, as discussed in **Section 2.1.2.4 Wetland Mitigation Site**, in 1996, SMVC entered into a “Wetlands Easement Agreement” (the Agreement) with The Telluride Company for the 20.8 acre mitigation site on the Study Area (**Photos 161 and 162**). Under the terms of the Agreement, the Telluride Company was authorized to access the site for the purpose of “restoring, creating, monitoring and maintaining a wetlands area” as it related to Civil Action No. 93-K-2181 (EPA vs. The Telluride Company). The terms of the agreement were valid until:

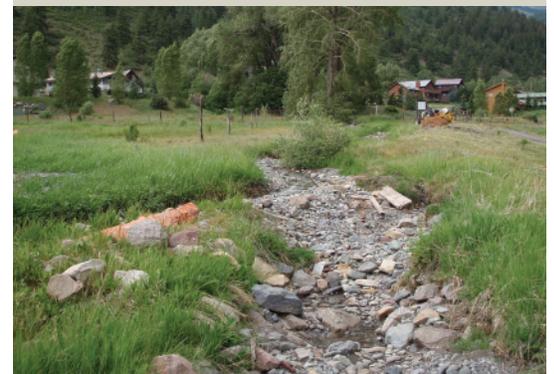
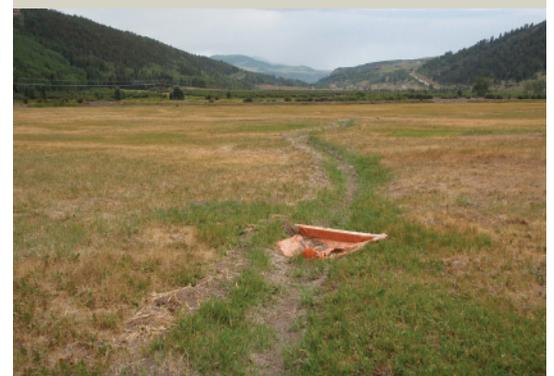
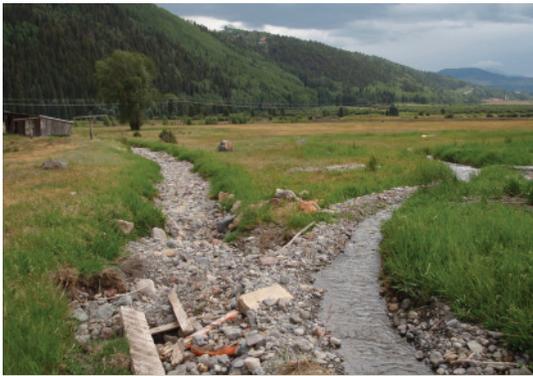
An existing network of ditches and laterals supply irrigation water to the meadows on the Study Area. These networks are used for irrigated pastures (**Photos 169, 170, 171**). General recommendations include:

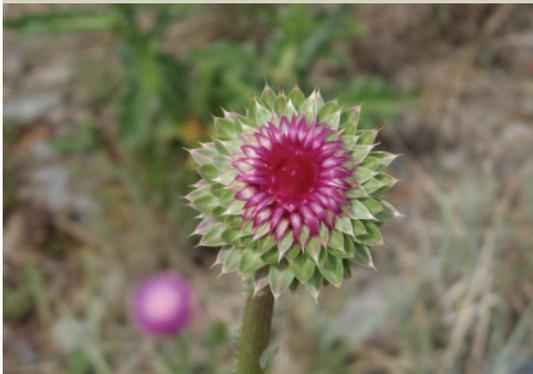
Photo 172

The Study Area currently has few issues related to noxious weeds. However, future changes in management, uses, and ground-disturbing activities (i.e., restoration, trail installation) may provide a foothold for noxious weed infestations (**Photos 172 and 173**). General recommendations include:

- Work closely with the San Miguel County Weed Control Program or other appropriate organizations to develop weed management strategies and to implement control techniques.

- Develop an integrated weed management strategy that includes a combination of mapping, mechanical, cultural, biological, and chemical techniques.
- Consider test plots for different and alternative weed control methods.
- Consider adverse impacts on non-target native vegetation and wildlife species before applying any weed control action.
- Map, on an annual basis, distinct patches or infestations of noxious weeds.
- Emphasize proactive monitoring and prevention to identify and control weeds before they become major infestations.
- Incorporate weed monitoring and control into restoration plans following ground-disturbing activities.

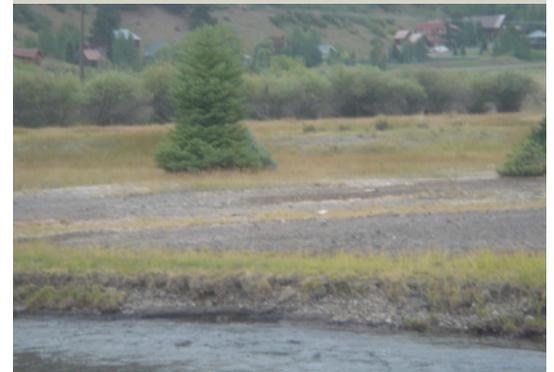
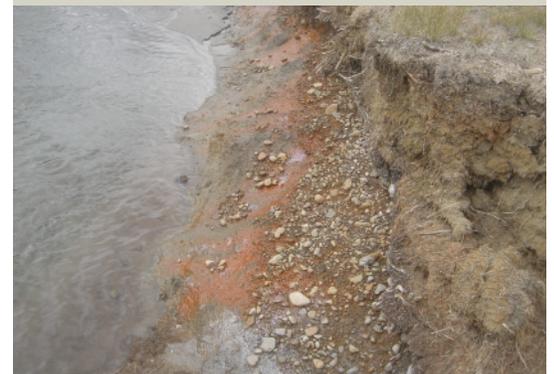
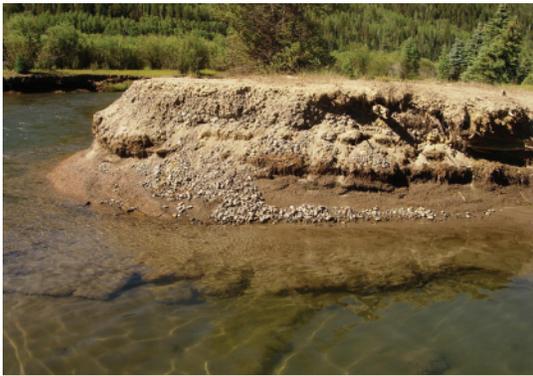
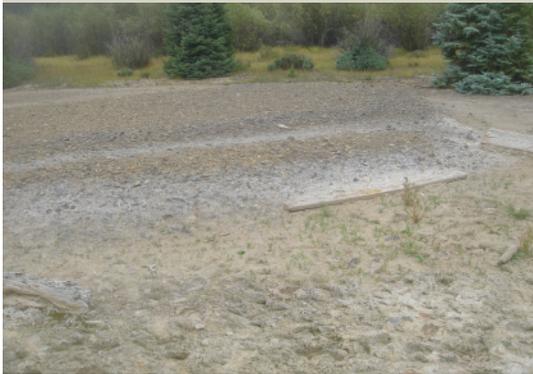
Tailings piles identified on the Study Area are generally locations of poor vegetation, unstable slopes, and potential health hazards (**Photos 175, 176, 177, 178**).

Restoration plans for the Society Turn Tailings Pile #1 have been approved as part of Idarado's Consent Decree agreement with the EPA. The current plan for these areas is to cap the tailings with 1 foot of soil and revegetate the surface with forbs.

The remaining tailings piles are not included in Idarado's Consent Decree and therefore do not have a current tailings reclamation plan. Multiple options exist for reclaiming the other piles including:

- Active revegetation of tailings
- Grading, stabilization and revegetation of tailings
- Grading, stabilization, capping and revegetation of tailings
- Potential in-situ treatment of tailings
- Consolidation of tailings piles
- Removal of tailings pile (to off site location or to Tailings Pile #1)

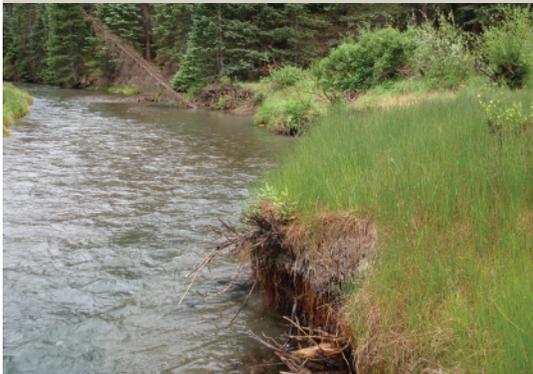
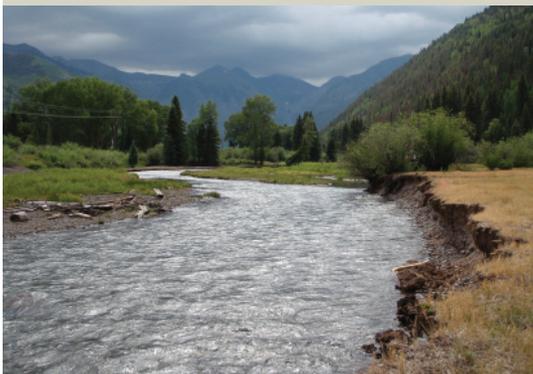
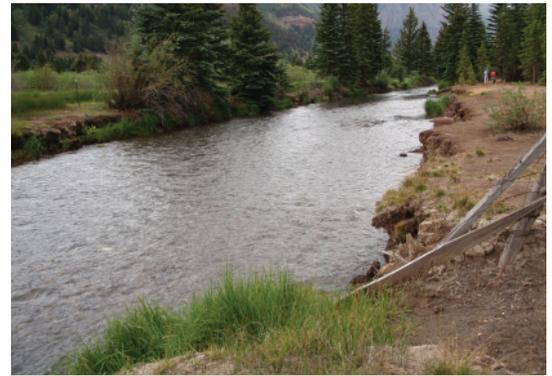
The health of the San Miguel River itself and the ecological benefits it provides have been significantly impacted. Impacts include channelization, loss of connectivity to its floodplain, eroding banks, lack of riparian vegetation, poor in-stream habitat, and confinement (**Photos 179, 180, 181**).

Channel restoration should focus on returning the San Miguel River channel to a planform and profile typical of a natural channel. Restoring the form of the San Miguel River would enhance the function of the stream system. Using the Rosgen Classification System, the San Miguel River through the Study Area would naturally be a Type C stream. A Type C stream is generally a meandering low gradient channel. Riffles/pool sequences and point bars are typical of this stream type. A Type C channel system has a broad, well defined floodplain that the channel accesses during high flow events.

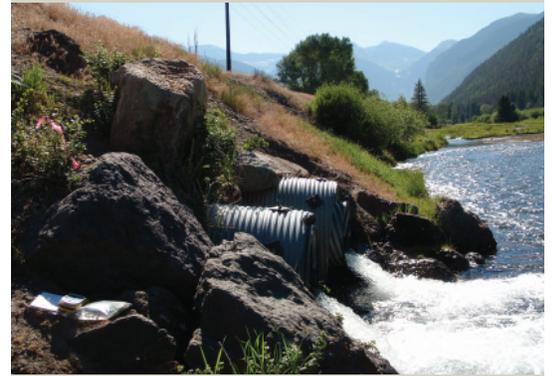
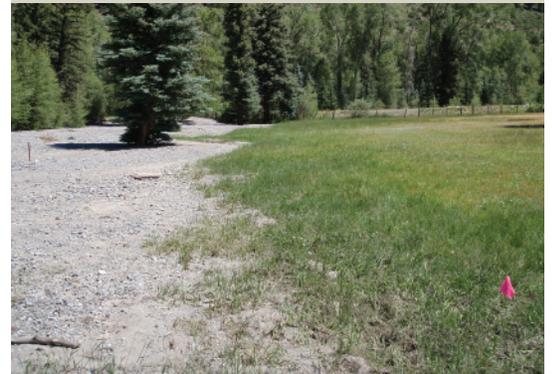
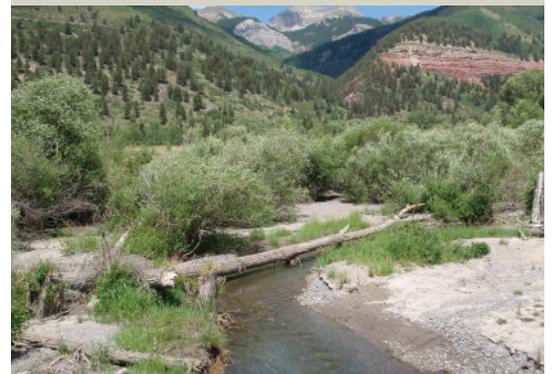
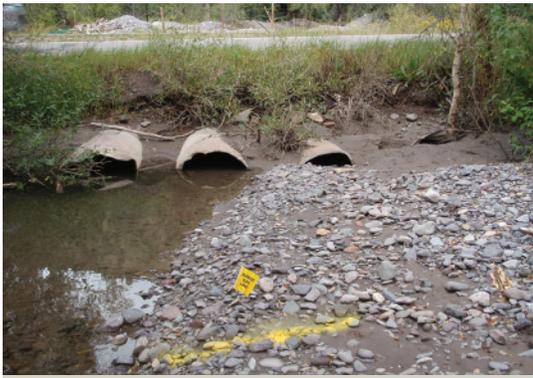
The Mill Creek drainage has been disrupted by the undersized culverts under the Spur and by the culverts under the railroad grade, near its confluence with the San Miguel River. Both crossings fragment the natural riparian system and cause disconnectivity of resources. The crossings also negatively impact the flow regime and sediment transport. Between these two crossings the channel has been impacted and improvements are recommended (**Photos 182, 183, 184, 185**).

The most important piece of restoring Mill Creek is to address the crossings. Widening the highway crossing and eliminating the railroad grade (or portion of the grade) at the confluence with the San Miguel River would improve the hydraulics of the drainage and potentially reconnect the riparian system along Mill Creek, re-establishing an appropriate channel shape and function.

From where Mill Creek enters the Study Area to the confluence with the San Miguel River, instream improvements including habitat work, bank stabilization, and revegetation would enhance the system. Similar to the San Miguel

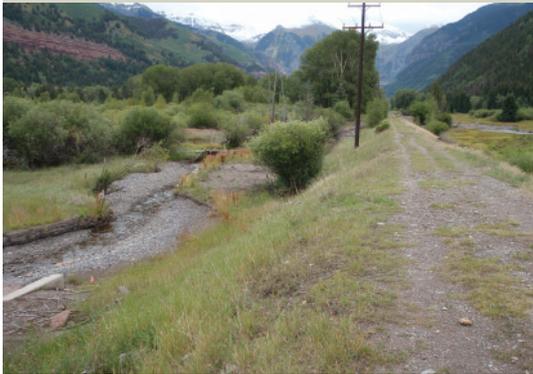
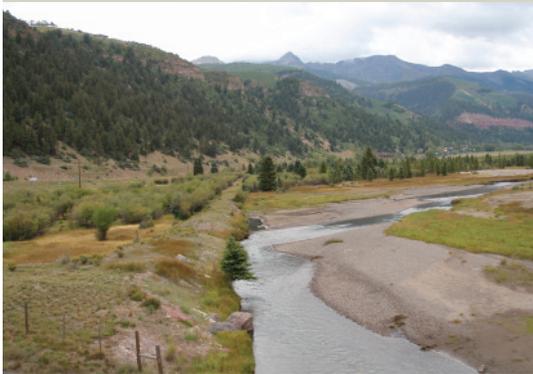
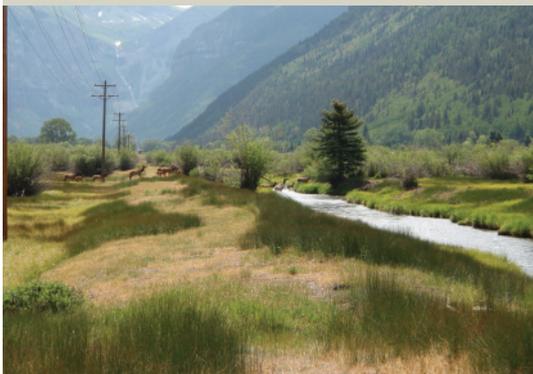
The railroad grade causes significant impacts on the ecology of the Study Area. In some areas, the grade restricts surface water flows; in other areas, it fragments habitat. It eliminates the San Miguel River's ability to migrate laterally and access its floodplain. The presence of the railroad grade impacts nearly all resources on the Study Area, either directly, indirectly, or both (**Photos 186, 187, 188**).

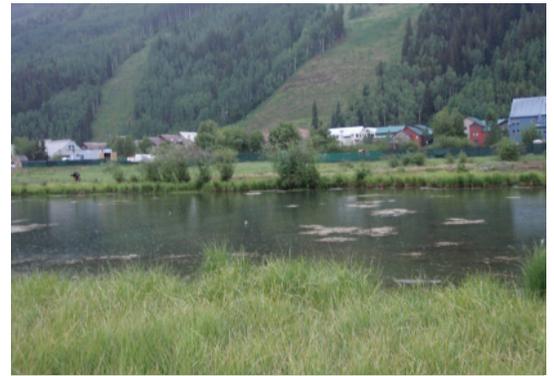
Photo 189

Sewage lagoons were excavated at the far eastern end of the Study Area. Groundwater was intercepted during the construction of these ponds and as a result they were not used as designed. The ponds affect the hydrology of the local wetland community (**Photo 189**).
