# Telluride Valley Floor

## Environmental Report

May 2009

Prepared by:  
Ecological Resource Consultants, Inc.  
ERO Resources Corporation

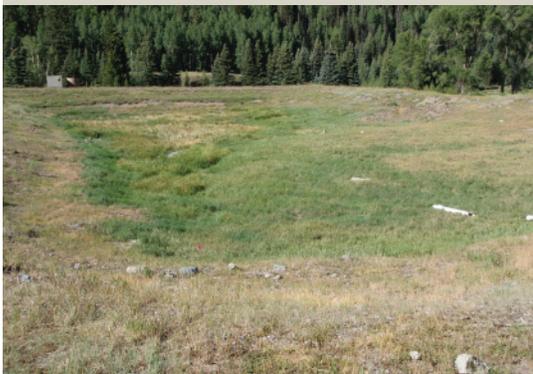
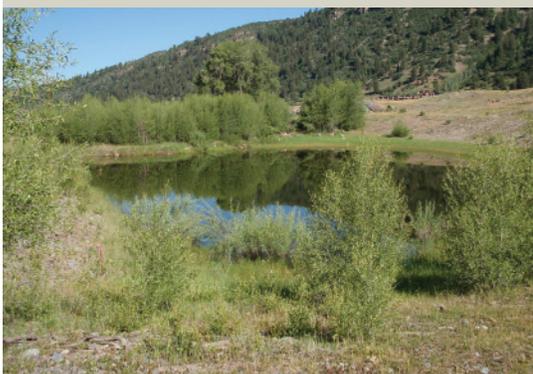
An abandoned sewer pond system exists east of Eider Creek and north of the San Miguel River. Two separate ponds currently exist, one north and one south of the railroad grade. In addition, topographic depressions and unnatural grading exists in the area. The excavated ponds and surrounding area is engineered in character, likely disrupting local hydrology, and providing habitat that is below the area's potential (**Photos 195 and 196**).

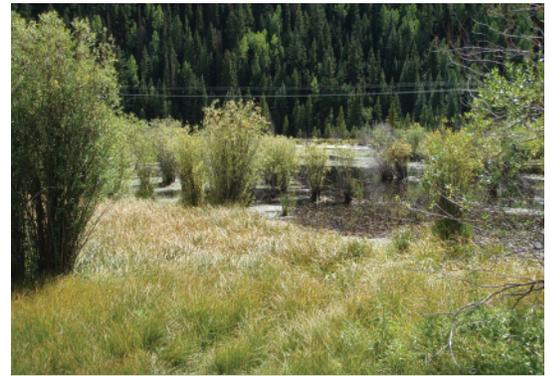
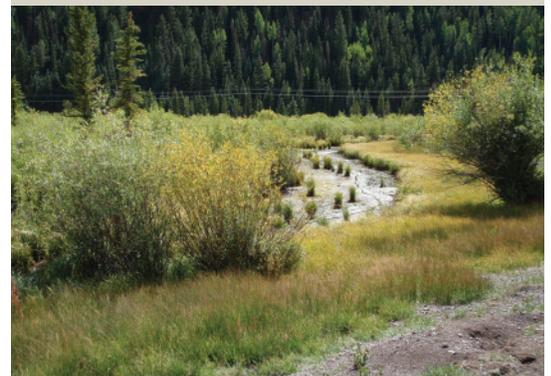
The confluence of the historical Cornet Creek drainage and the San Miguel River has been disrupted as a result of the railroad grade. Hydrology and continuity of the riparian system are cut off by the berm (**Photos 197 and 198**).

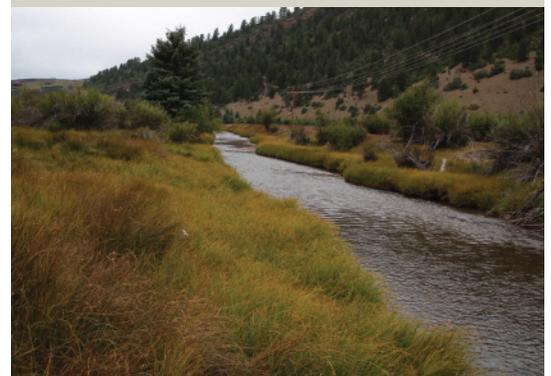
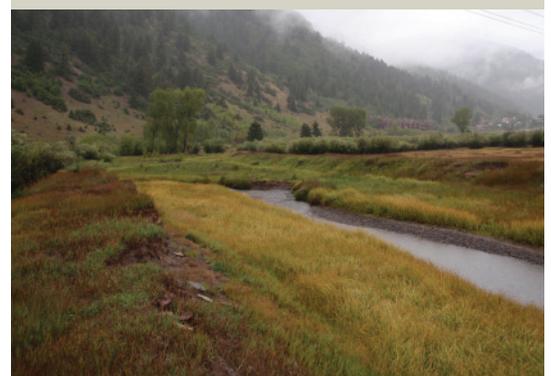
In several locations in the Study Area, berms have been constructed, either intentionally to confine surface water or other features or unintentionally as the result of excavation for other purposes. These berms currently disrupt surface and groundwater flow patterns, fragment habitat, and cut off the natural floodplain in areas (**Photos 199 and 200**).

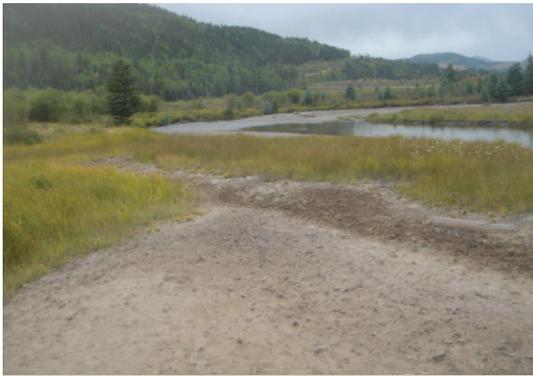
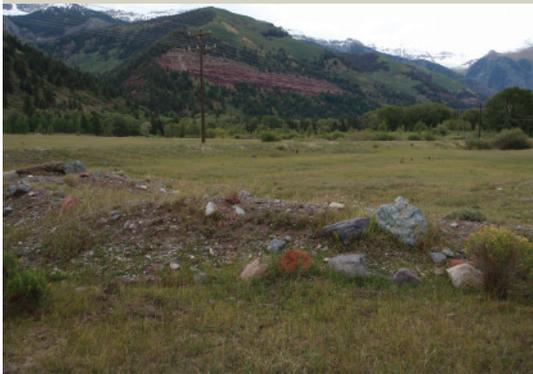
Debris piles are present in several locations around the Study Area. The piles decrease the aesthetic appeal of the area (**Photos 201 and 202**).

When removing debris, care should be taken to minimize impacts to surrounding areas and ingress/egress paths. The cultural significance of debris should be verified prior to removal.

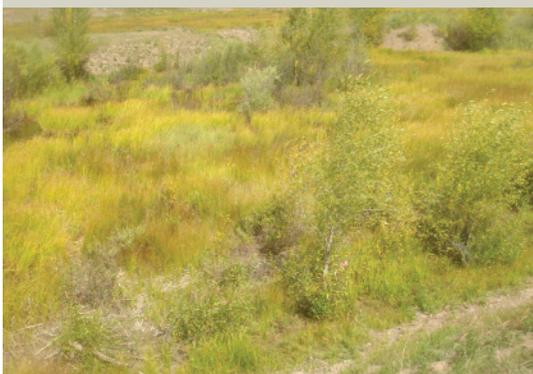
Photo 204

An abandoned pond system exists between the main stem and the north fork of the San Miguel River just west of the confluence of Eider Creek. The excavated pond is engineered in character, likely disrupting local hydrology and providing habitat that is below the area's potential (**Photos 203 and 204**).
